Drawn: KL
Date: 20.06.2022
Project No.: 22-025
Cad File:
Drawing No.: Sheet 1 of 2

Title: Site Analysis / Existing Conditions Plan
- Brown Hill Recreation Reserve, Ballarat

SITE ANALYSIS / EXISTING CONDITIONS PLAN
BROWN HILL RECREATION RESERVE
CITY OF BALLARAT

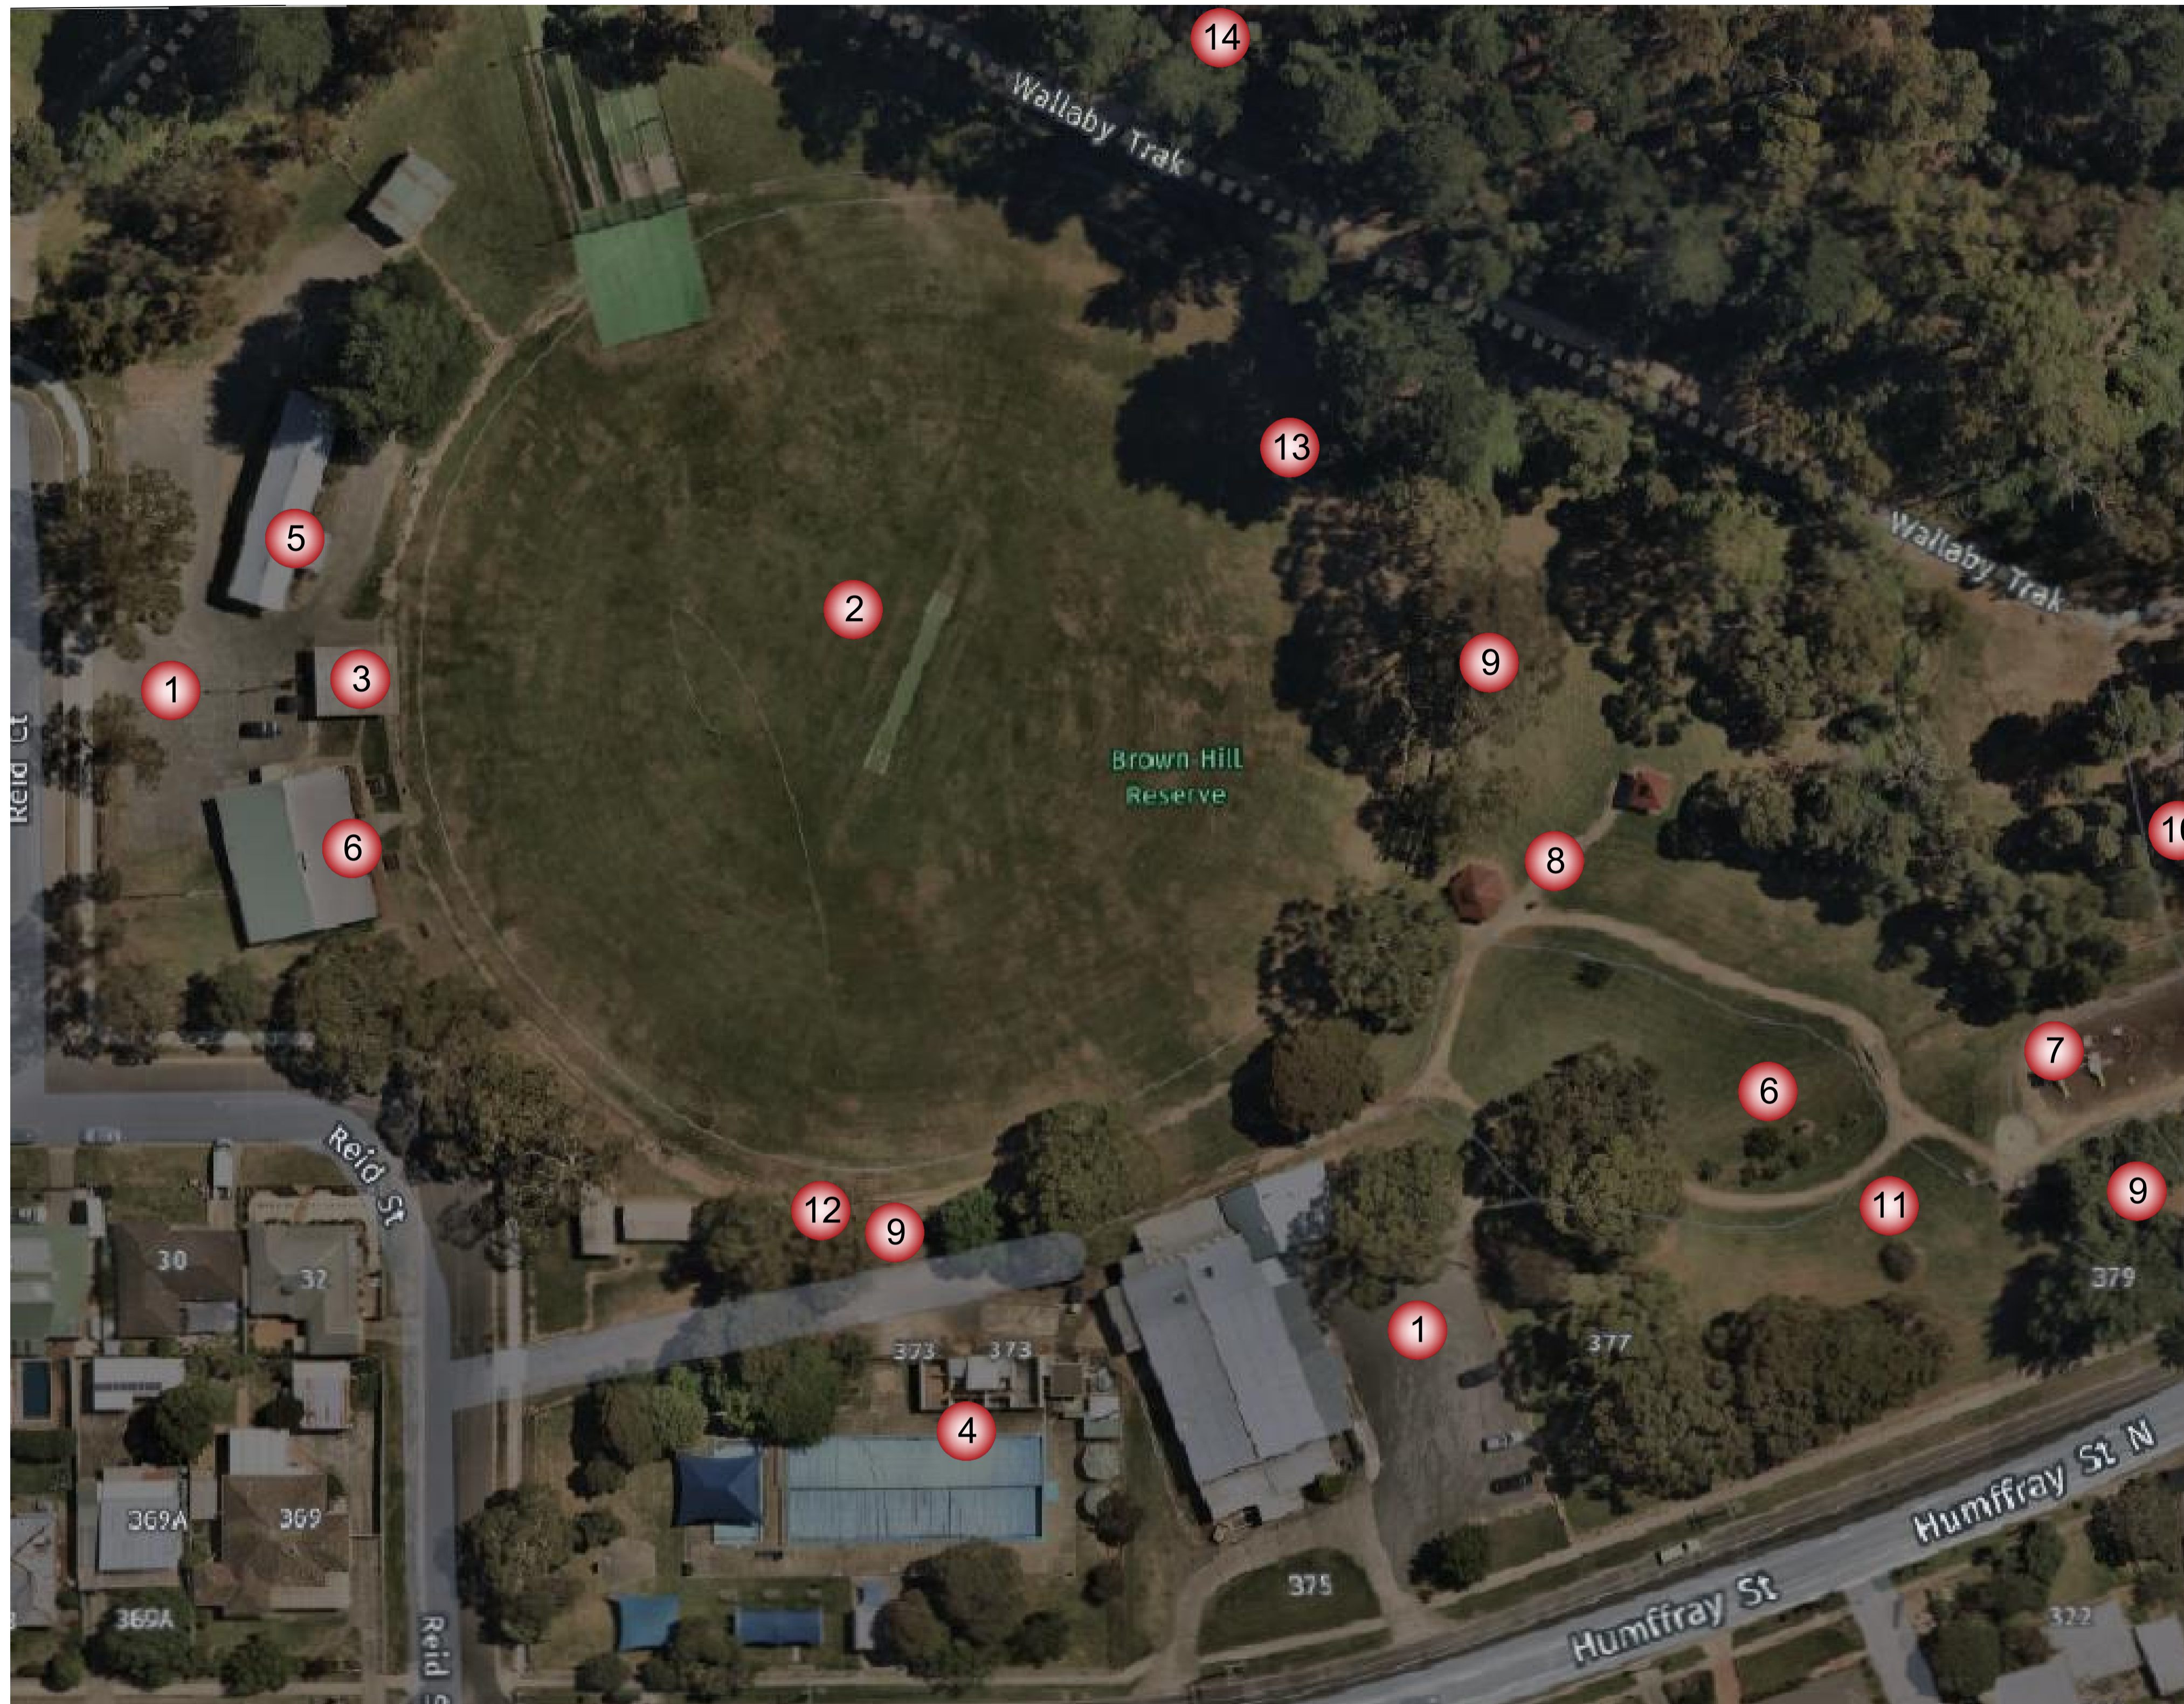
ANALYSIS	
1	Carparking not delineated
2	Oval not drained or irrigated.
3	Public toilets poor located and in decline.
4	Swimming pool in decline; Area at back of swimming pool in unsightly condition.
5	Band Hall ageing and in decline.
6	Basic pavilion with no changerooms.
7	Basic playground.
8	Limited path network
9	Limited park seating and furniture.
10	Narrow and ageing footbridge.
11	Install adult exercise equipment as several fitness stations as part of a pathway circuit.
12	There is a build-up of organic debris (leaf litter and twigs) from surrounding trees.
13	There are exposed tree roots within the oval's surface at the north east section of the oval.
14	The existing pine trees to the north, shade the northern section of the oval in winter.
